Lakewood East Neighborhood Parking Study

Draft Assessment Report

Prepared for the City of Coconut Creek
Broward County, Florida

April 2025

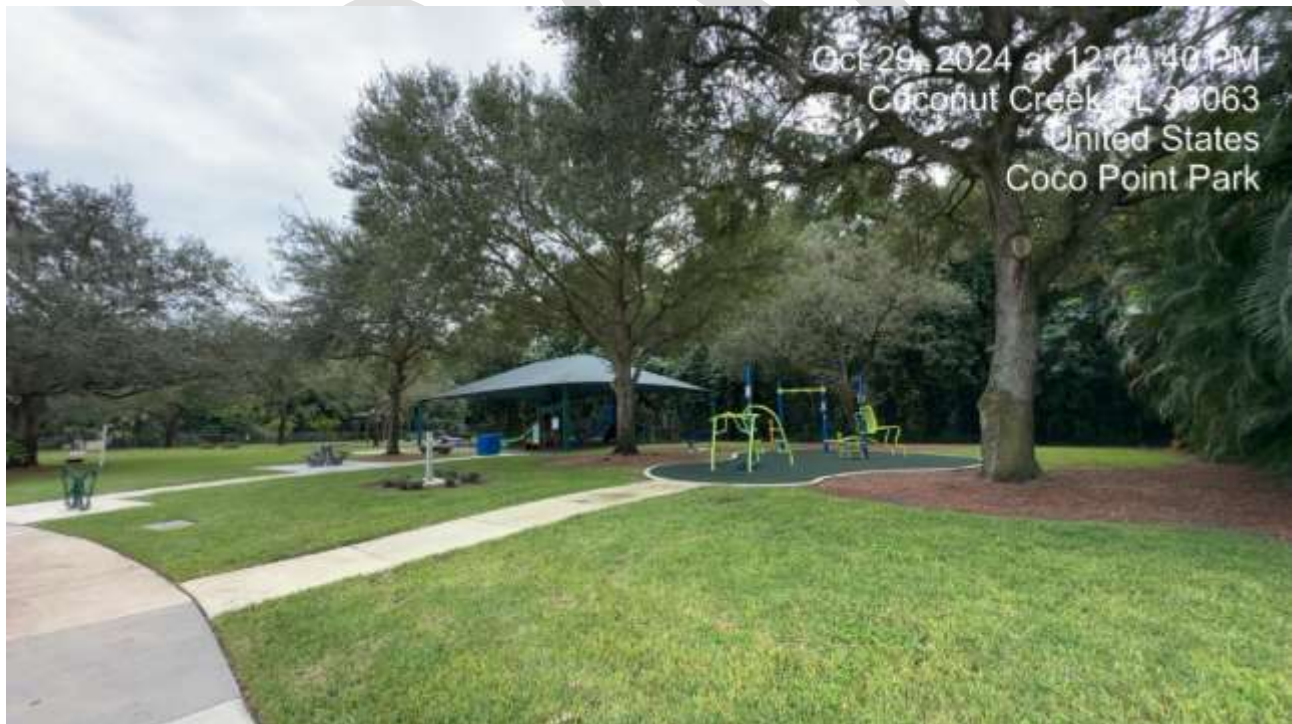
**Figure 4-1: Coco Point Park**

- Coco Point Park lacks designated parking and vehicles park on the swales, see **Figures 4-1 and 4-2**.
- Lakewood Park lacks designated parking and display “No Parking” signage, see **Figure 4-3**
- Parking demand peaks during weekdays in the evenings as residents park on swales due to insufficient space on their driveways to accommodate multiple vehicles per home; see **Figures 4-4 and 4-5**.

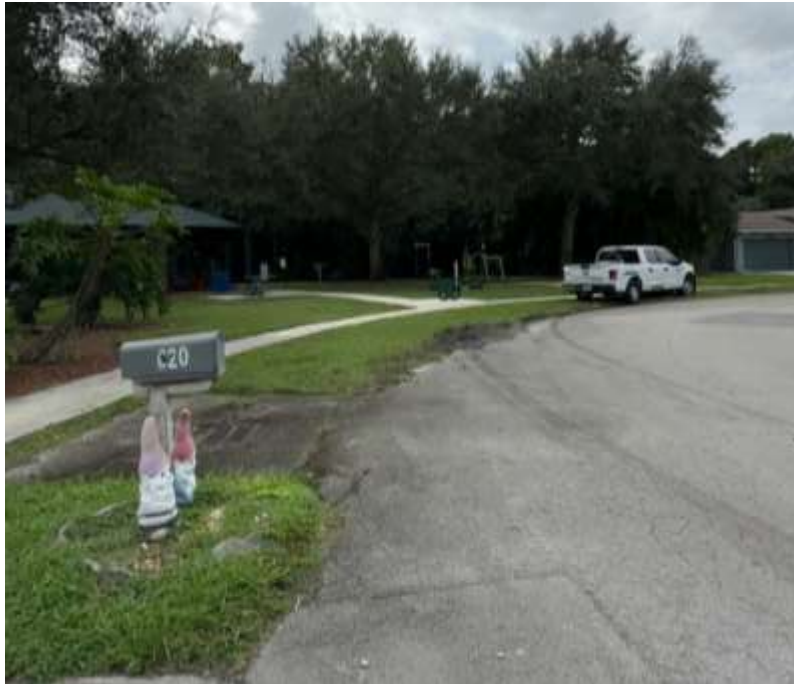
Figure 4-2: Coco Point Park's Lack of Designated Parking and Damaged Swales

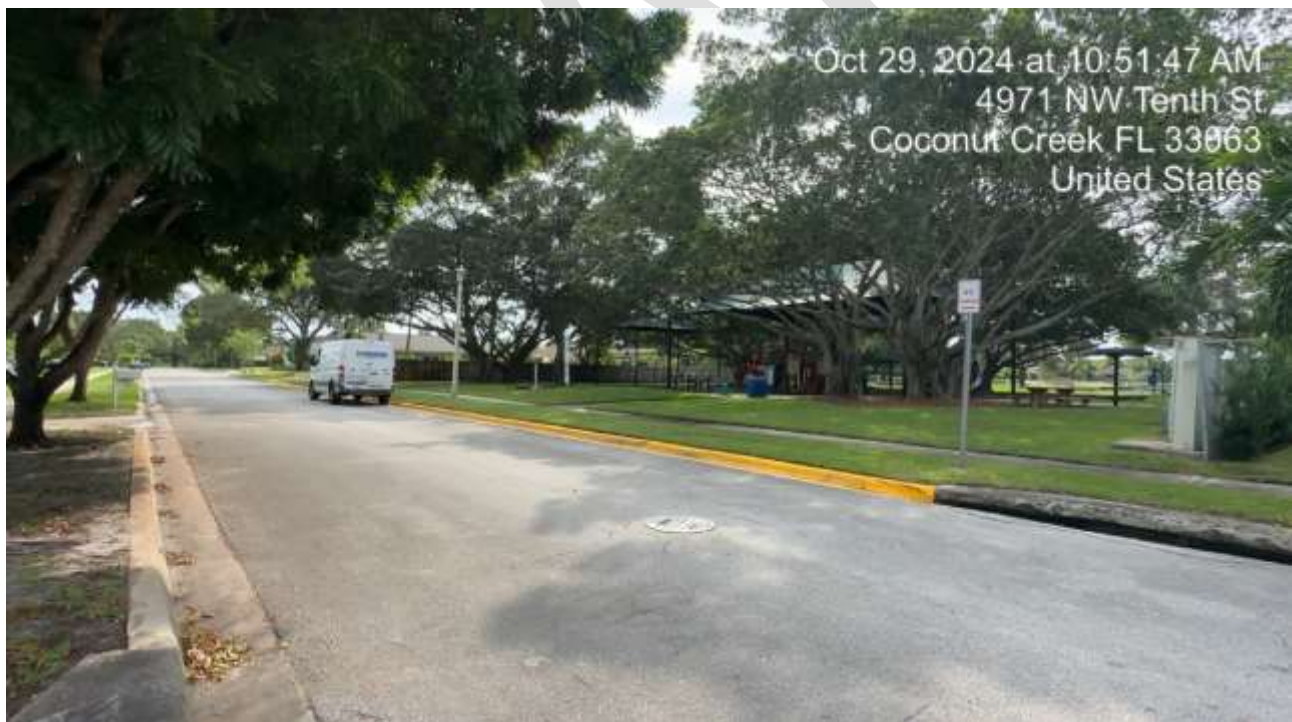
Figure 4-3: Lakewood Park and its "No Parking" Signage

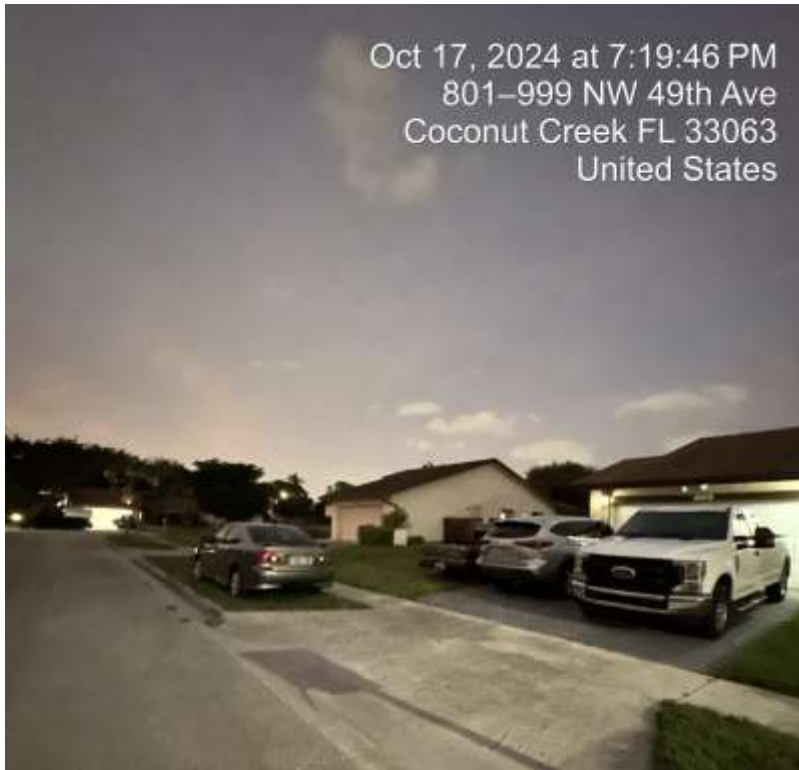
Figure 4-4: Home with Multiple Vehicles

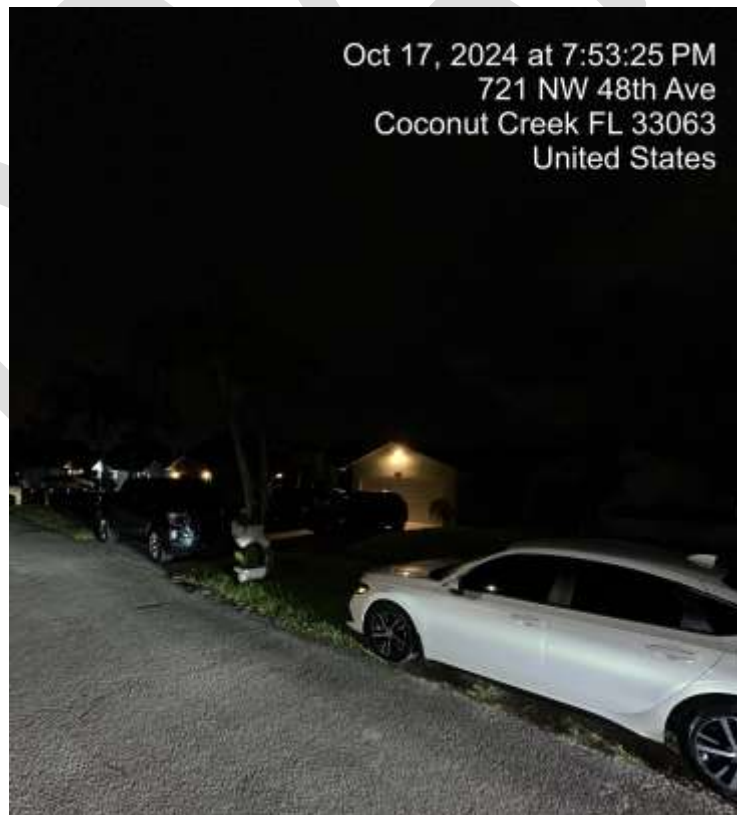
Figure 4-5: Overnight Swale Parking

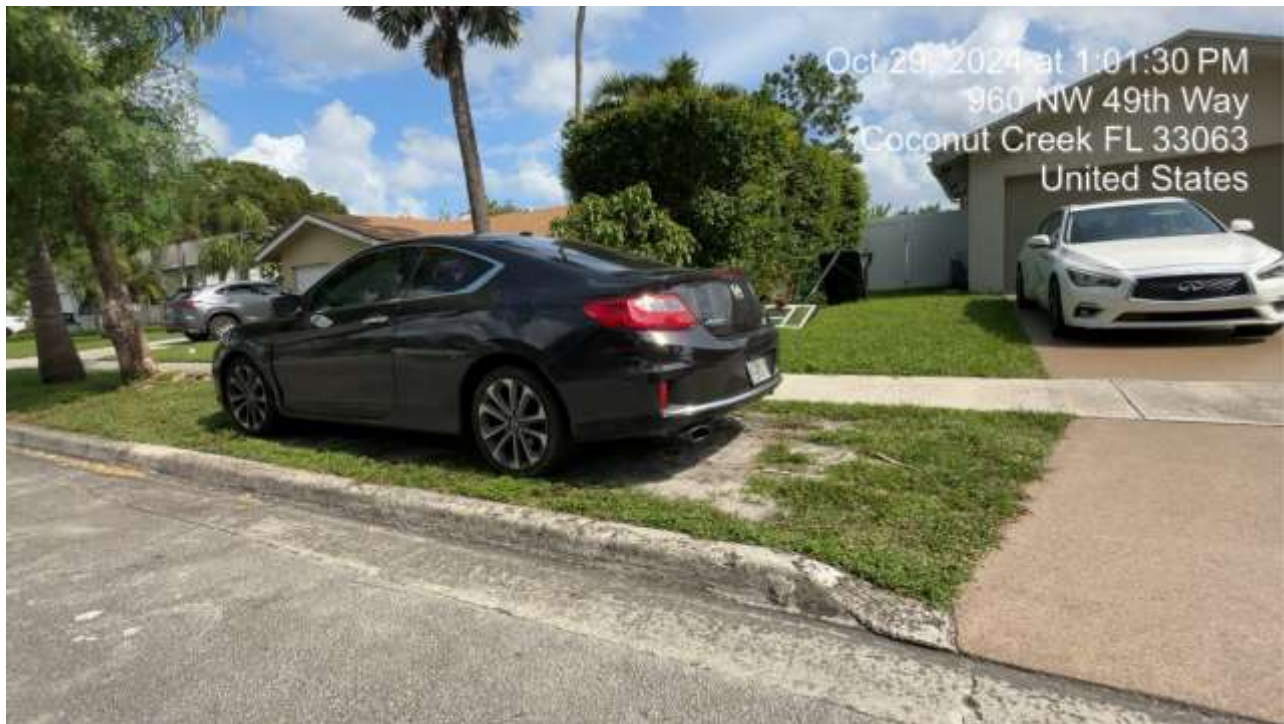
- Parking demand peaks during weekend evenings, with overflow often leading to recurrent parking on swales, see **Figure 4-6**.
- Occasional instances of on-street parking limit street access, particularly on narrow roads, and pose barriers to essential services like street sweeping. Especially in instances when two vehicles are parked on both sides of the same street location.

Figure 4-6: Recurrent Vehicle Parking on Swales

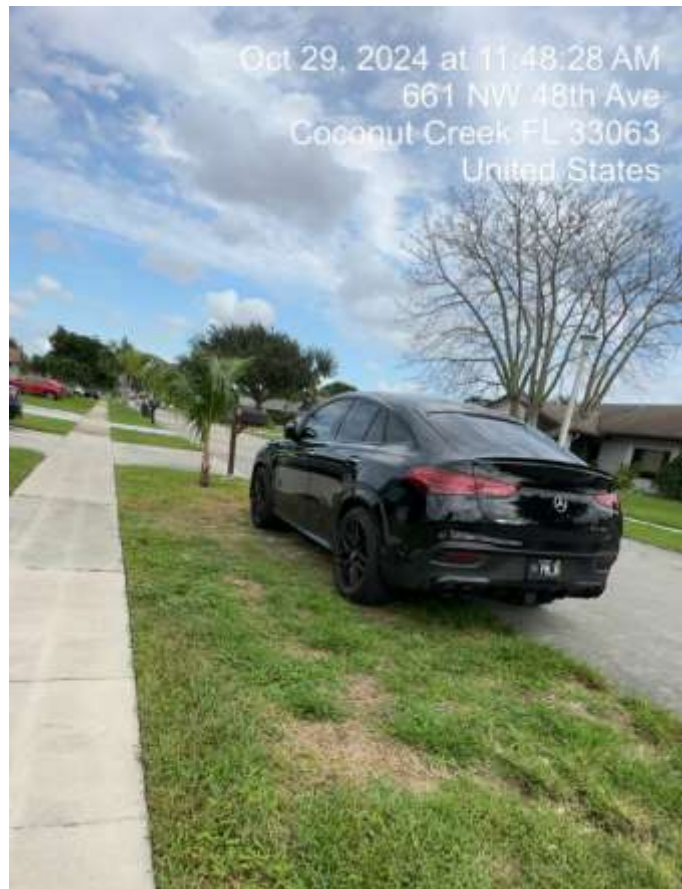
The condition of swales in these neighborhoods varies, with some areas experiencing compaction and erosion due to frequent vehicle use. Such swale degradation impacts aesthetics and compromises drainage function, posing possible flood risks during heavy rains. Well-maintained, landscaped swales in specific areas contribute positively to neighborhood appeal and stormwater management and are recommended to remain undisturbed. Restoration is advised in areas with visible swale damage, including options like resilient ground cover and barriers to deter parking.

Figure 4-7: Swale Parking and Eroded Conditions
