Lincoln of Coconut Creek "Lincoln Wall Logo" Sign Deviation

5501 W. Sample Rd. Coconut Creek, Florida 33073...Parcel ID #48218030022
Property Owners: TT of Sample Inc.

Detailed description of proposed Lincoln "Star" Logo Wall Sign

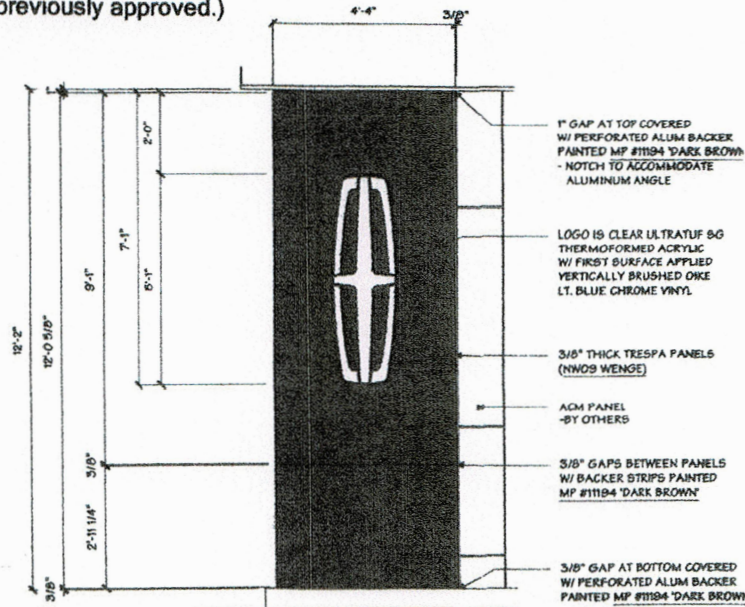
5'1" high by 1' 7" wide "Star" illuminated LINCOLN Star "LOGO" sign proposed to be installed on a 12'2" high by 4'4" wide dark brown painted (MP #11194) panel attached to the oversized corner column supporting the porte cohere roof. The 5'1" high Lincoln Star "LOGO" is clear acrylic with vertically brushed oik light blue chrome vinyl. The Lincoln wall logo sign is setback 17'6" from the front building elevation.

1. The 5'1" high illuminated logo sign exceeds the regulations of Sec. 13.466.8(c)(3) which a calculated non-linear sign may exceed the 3' maximum height but not the maximum height of 6'.. The sign's setback is a considerable distance from the public right of way and hence...the viewing public. The logo sign is 17'6" behind the front elevation of the dealership building that maintains an approximate 171' setback from the front property line which is also the north line of the frontage road which runs parallel to Sample Road but, said north line is approximately 110' from the north right of way line of Sample Road. Therefore, the logo sign is setback approximately 300' from the Sample Rd. right of way which is significantly greater than the typical setback for commercial buildings along the Sample Rd. commercial corridor.
