2022R072, 2.0 MG Reservoir Level 2 Inspection Report Coconut Creek, Florida ATTACHMENT "A"

ADD ALTERNATE #1

Interior Piping

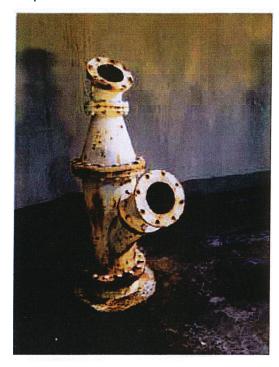
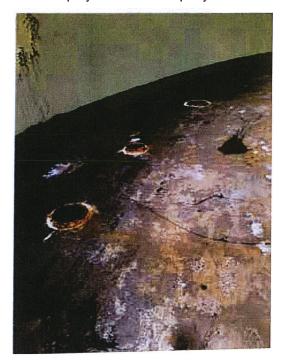
Condition Rating

Poor

Corrosion noted on interior DIP lines.

Prepare surface of corroded DIP lines and coat with a polyamidoamine epoxy.
